Graco 243222 Replacement Pressure Transducer

Atomex Part No. AX/G243-222

Replaces Graco Part No. 243222

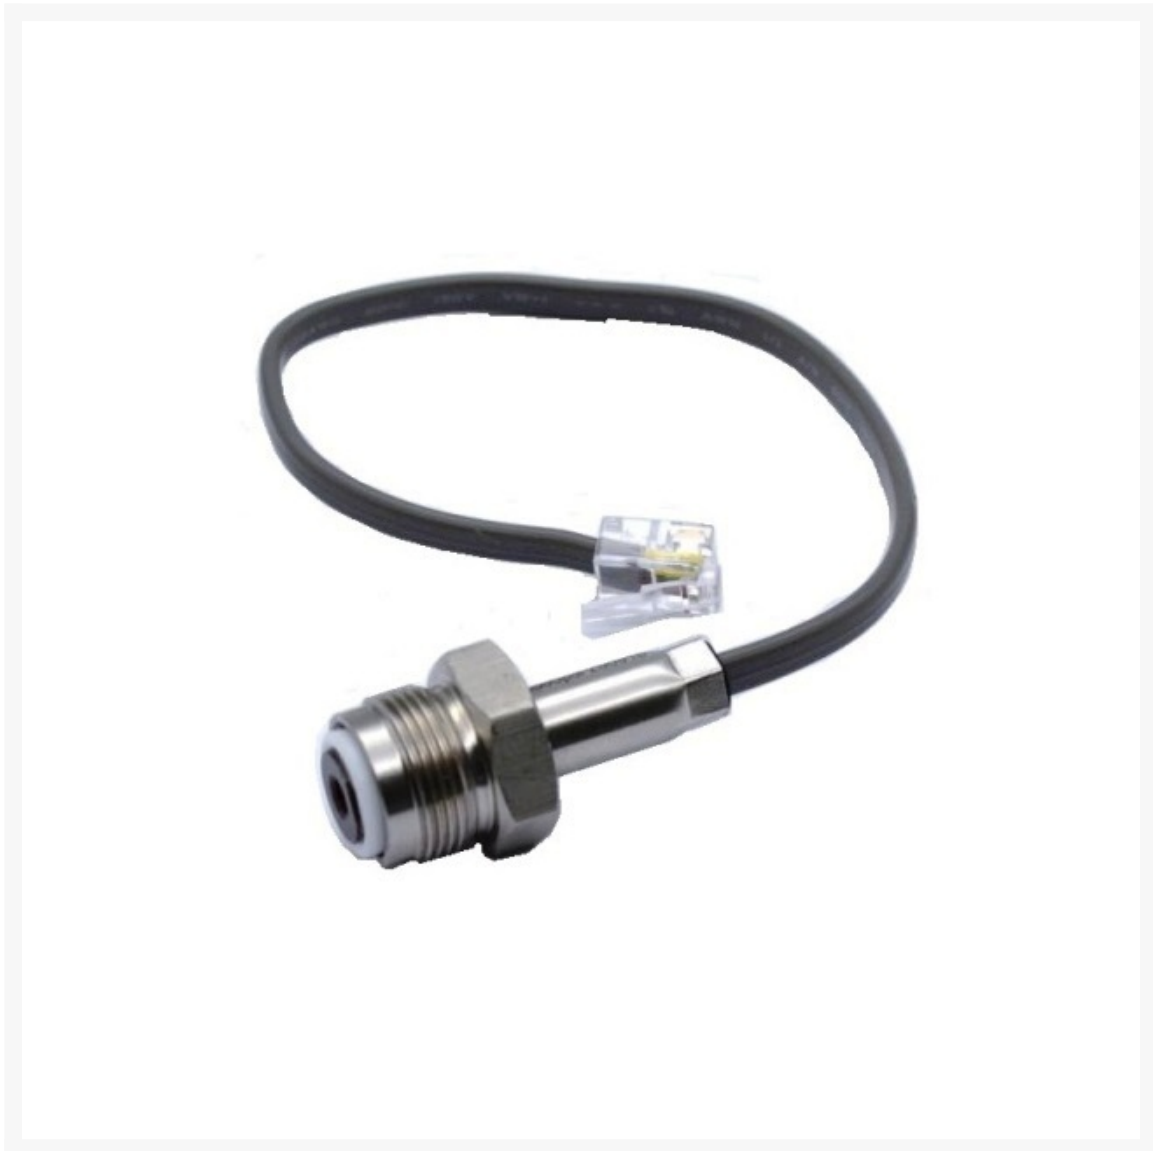
Product Images

Graco 243222 Replacement Pressure Transducer is used in a wide variety of Graco electric and petrol airless sprayer models. The pressure transducer connects between the high pressure filter and the control board. The transducer is designed to send a signal to the control board which uses this information to know when the sprayer has reached the maximum pressure.

Faulty transducers can cause the following error codes to appear in you digital display -

E=02 (High pressure signal from transducer)

E=03 (Transducer failure or connection error)

Faulty transducers can also allow your machine to run past the maximum pressure of 3300psi and not stop. Machines that over pressurise can be dangerous causing the paint hose to burst or other component damage such as pump or drain valve.

Transducer failure in Graco airless sprayers is a common occurrence and transducers are not serviceable they must be replaced.
