# Graco 248837 XTR5/XTR7 Replacement Airless Spray Gun Repair Kit

Atomex 248837 replacement Airless Spray Gun repair kit for XTR5 & XTR7 airless spray guns. Made in the USA.

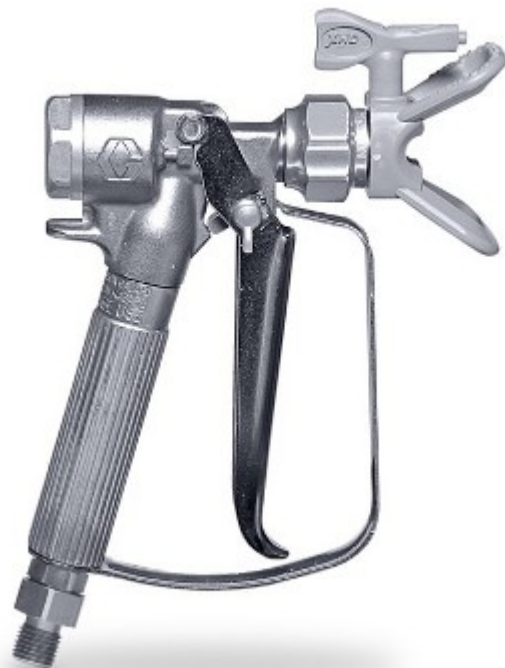
This gun repair kit will fit into guns that look like this

Graco XTR7: 248609, 248610, 248611, 248612, 248613, 248614, XTR700, XTR701, XTR702, XTR703, XTR704, XTR705, XTR706

Graco XTR5: XTR500, XTR501, XTR502, XTR503, XTR504, XTR505, XTR510
